Ecological Modeling at the Landscape Scale

US Army Corps
of Engineers

Engineer Research and Development Center

MAWI – Multi-scale Assessment of Watershed Integrity

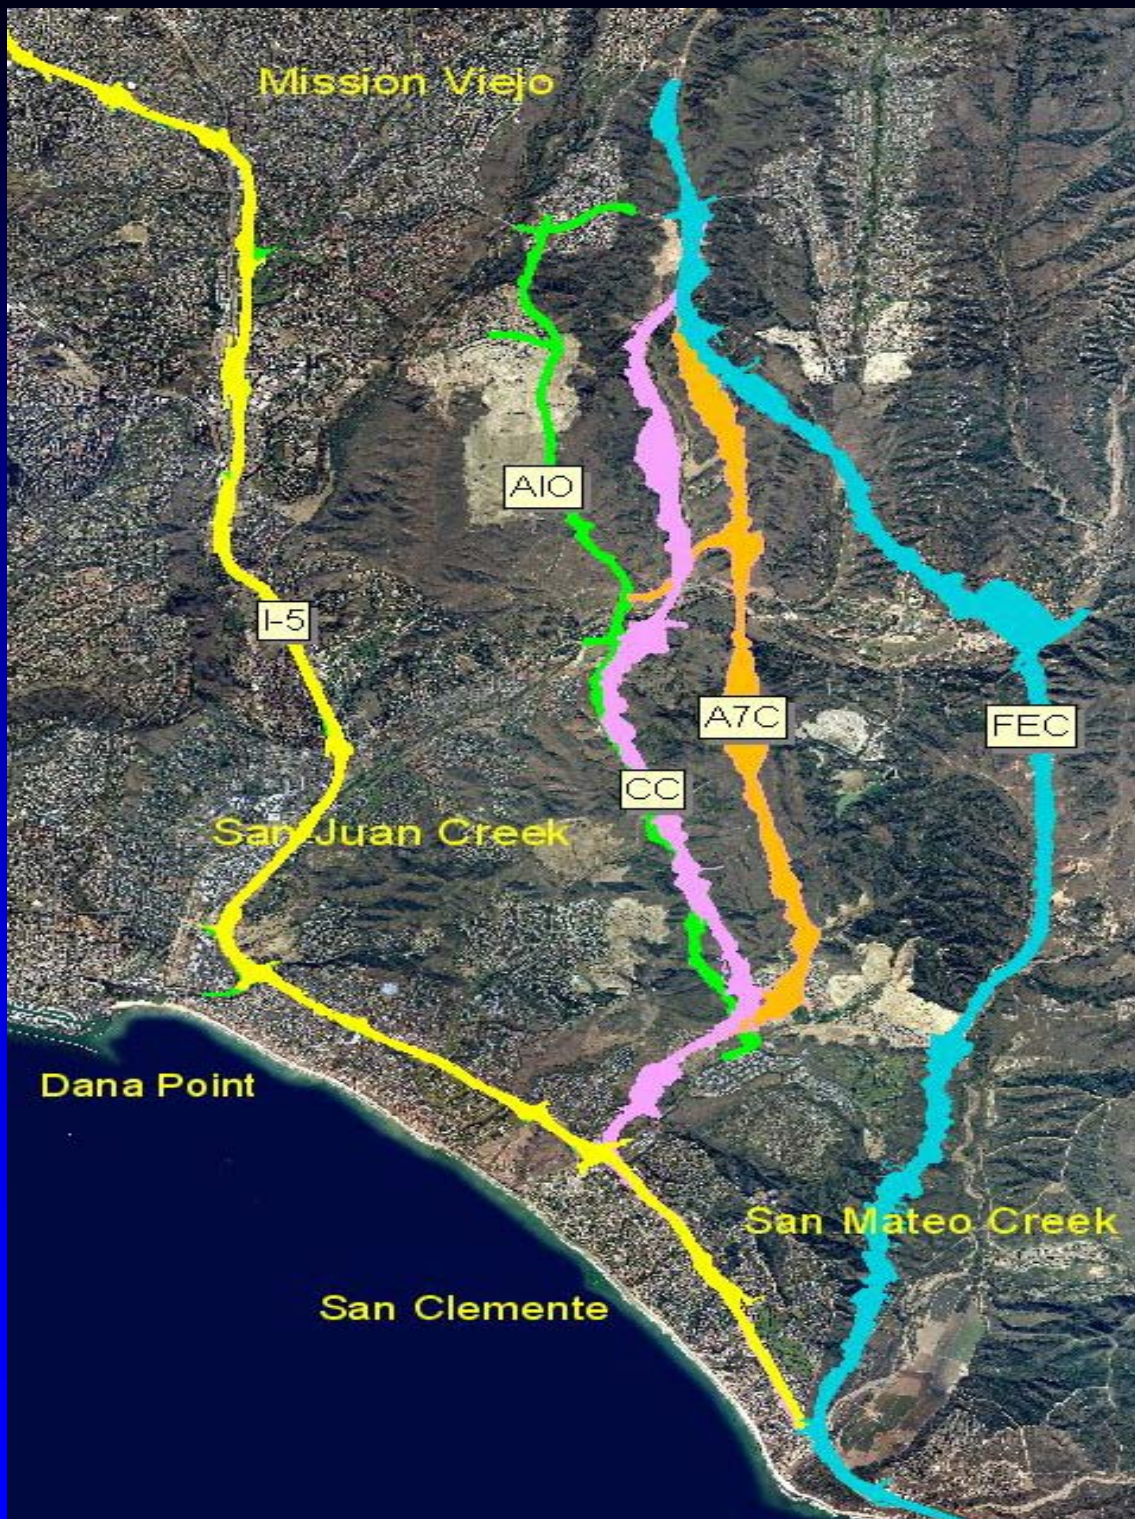
Incised Restoration Template

- ❖ Bankfull Width: 1.5 m
- ❖ Bankfull Depth: 0.15 m
- ❖ Flood Prone Width: 2.4 m
- ❖ First Terrace Width: 1.8 m
- ❖ Second Terrace Width: NA
- ❖ Height above Bankfull: 0.45 m
- ❖ Height Above Bankfull: NA
